Development of Supermarine's single engine seaplanes

Walrus Mark identification.

The Stranraer

Colour profiles

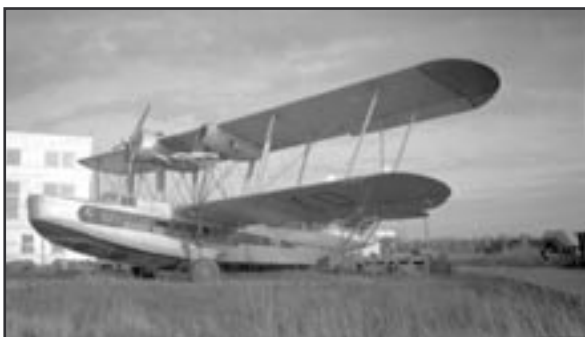
Sole surviving Stranraer CF-BXO looking somewhat neglected and missing the port engine after its use in civilian hands was over and before coming to the RAF Museum. (CanAv)

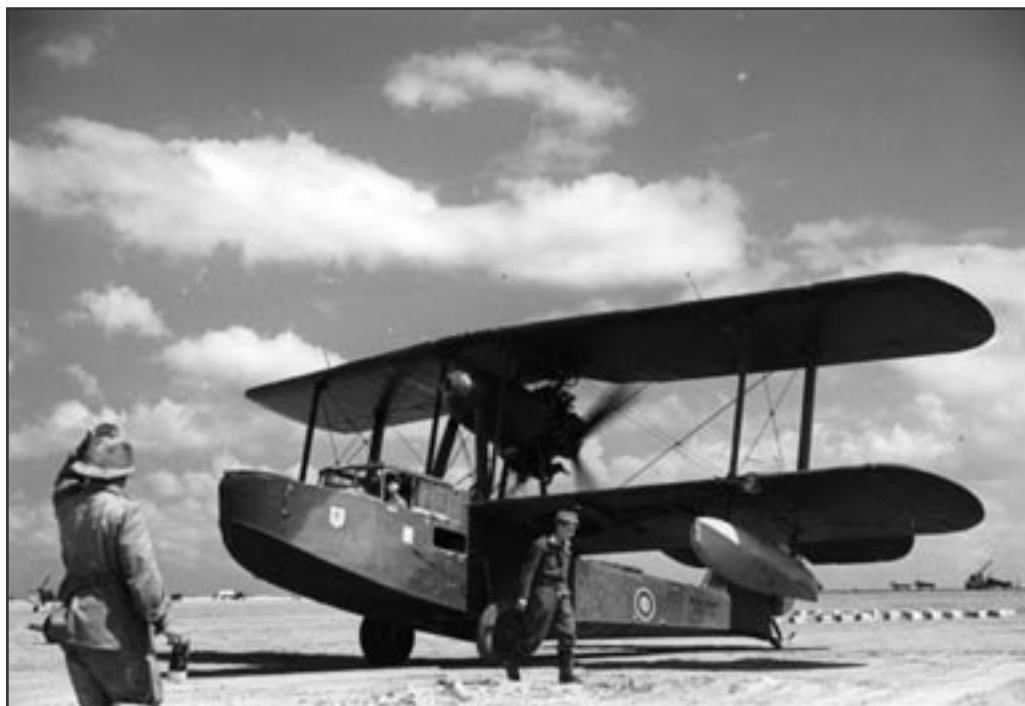
Walrus I W2706, of the RN/RAF combined Air Sea Rescue Flight, North Africa. This photo probably taken at Bu Grara in March/April 1943, when the unit was flying rescue patrols along the Tunisian coast during the Mareth Line battles. Note the pale wing float – possibly an aluminium-doped replacement, or perhaps painted white or yellow for enhanced visibility?

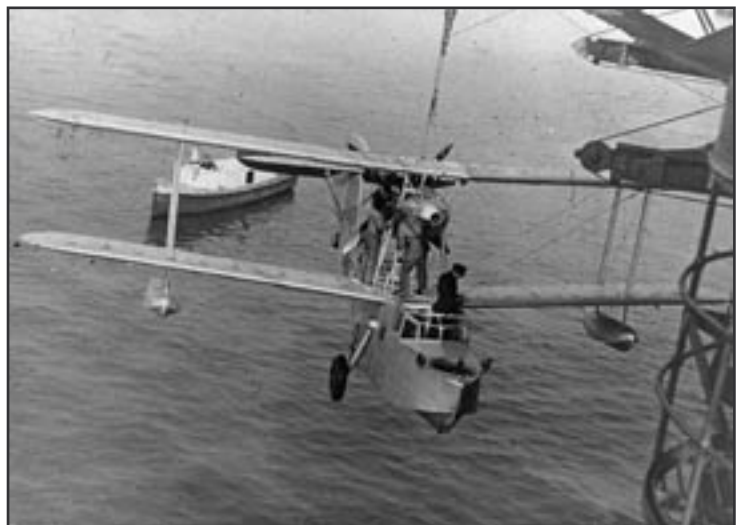
Seagull V prototype marked as N-2 (originally marked as "N-1"). Subsequently allotted the RAF serial K4797.

Lt Commander Caspar John in the cockpit of the Seagull V prototype being hoisted aboard HMS Courageous in Portsmouth Harbour at the start of the first sea trials in February 1934. Numerous details are worth identifying, including the two compasses mounted on the bow, and the non-standard (for later Walrus and Seagull V) ladder for access to the engine.

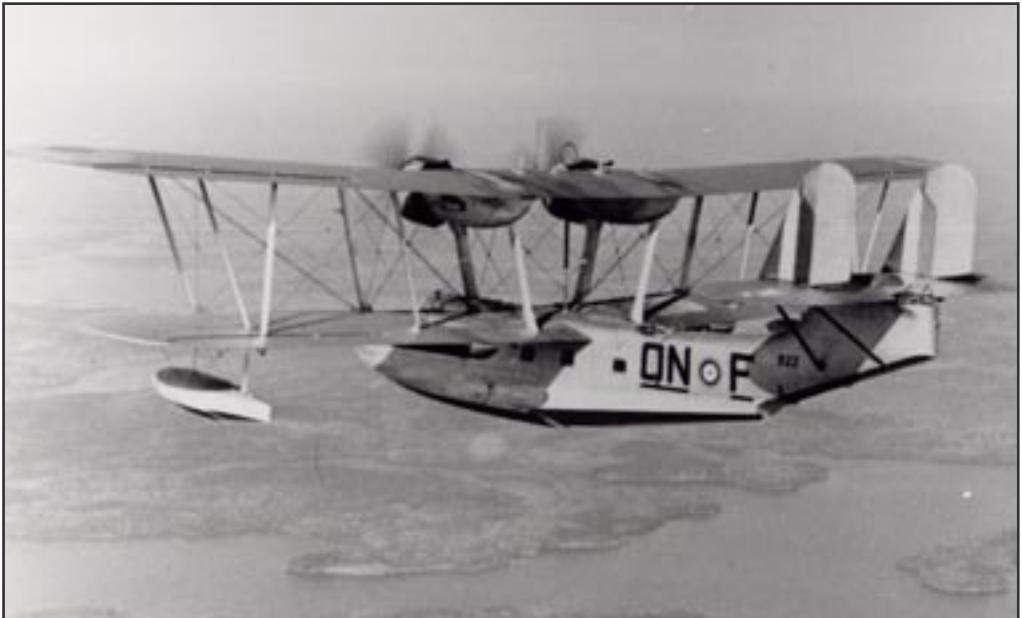
Interminable hours were spent by Stranraer crews on patrol. Stranraer 922 is prepared for a particularly long one, as the long-range overload tank can just be seen below the port wing. This aircraft was burned and sank at its mooring at Alliford Bay, B.C. on New Year's Eve, 1941, due to 'carelessness'.

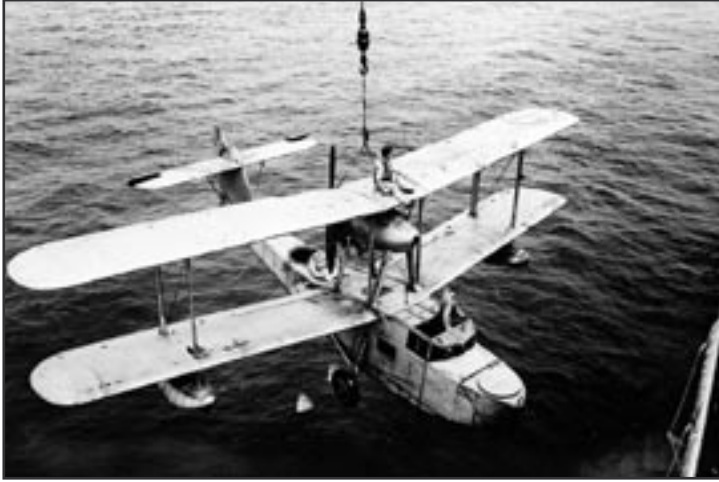
WALRUS - Floats & Undercarriage

This hard-used Walrus Mk.I being hoisted back aboard ship shows a good deal of otherwise unseen detail.

Two canvas sea-anchors are still deployed, hanging below the fuselage. Many of the access panels and inspection ports are visible as is the outline of the folding flaps on the lower wings. Although the camouflaged scheme is extremely worn and effectively indecipherable, two SEAC stars and bars can be discerned:

one on the fuselage, the other on the port wing. Unusually, sealant has been needed on the hull joints to prevent water ingress.

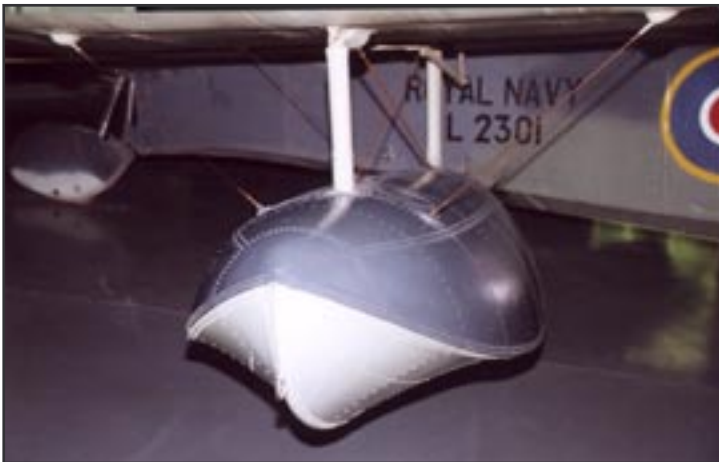
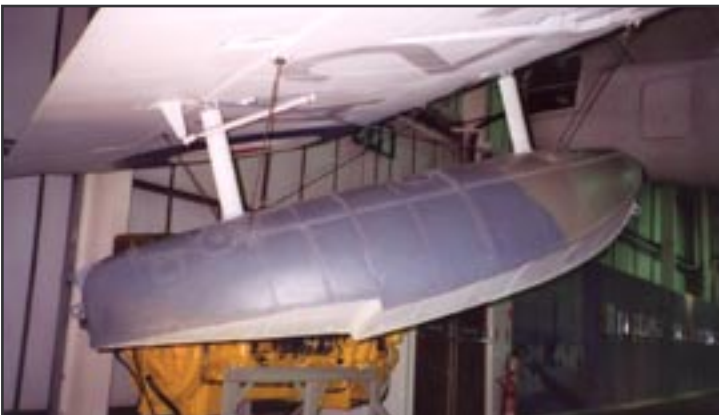
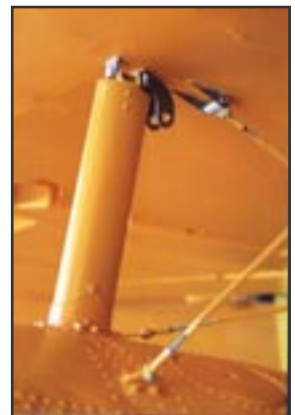
(FAAM) The wing float details. The production Walrus' float was deeper than the fatter and more flattened Sea Otter floats, and apparently larger than the prototype Seagull V.

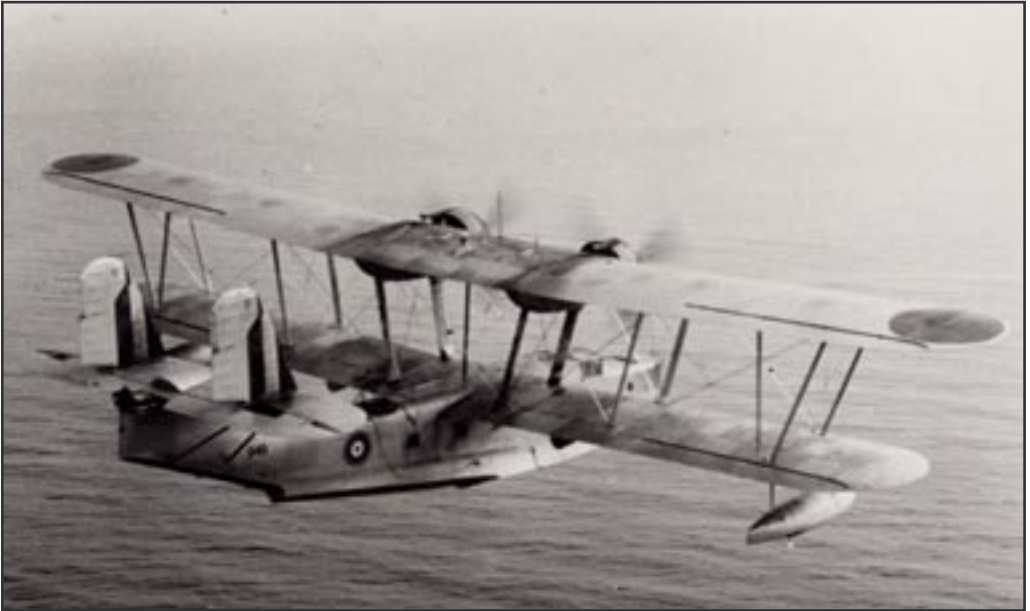
STRANRAER- Wings

Top:
Stranraer 949 displays its RCAF roundels and fin flash as well as the wear and tear flying boat operations engender. (Shearwater)

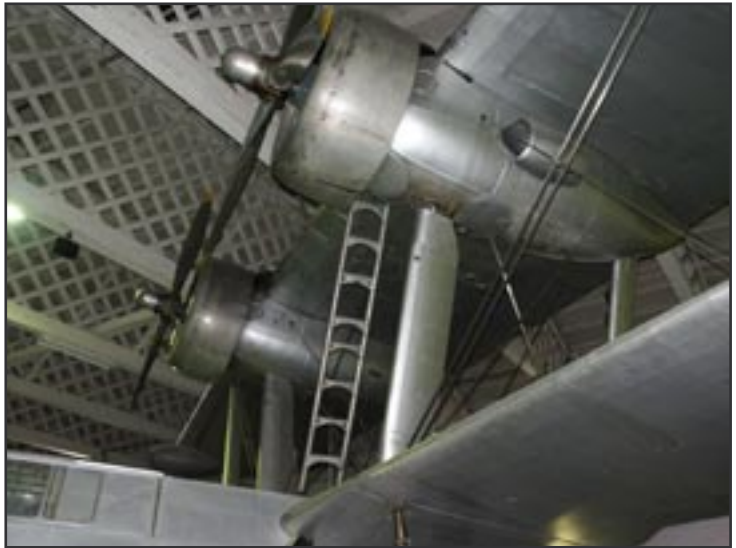
Above: *Early four-blade wooden propeller shown here in a photo from a private album. (Shearwater).*

Above Right: *The engines and nacelles on 920. The nacelles are the same as service Stranraers, but only civil machines were fitted with the Wright engines. (JDK)*

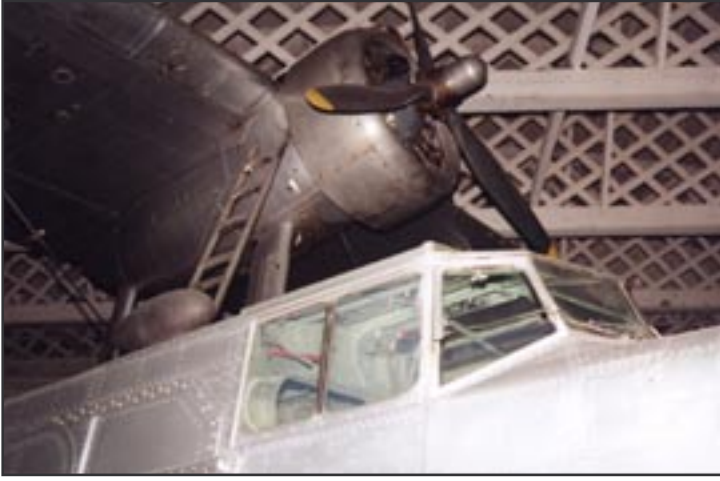
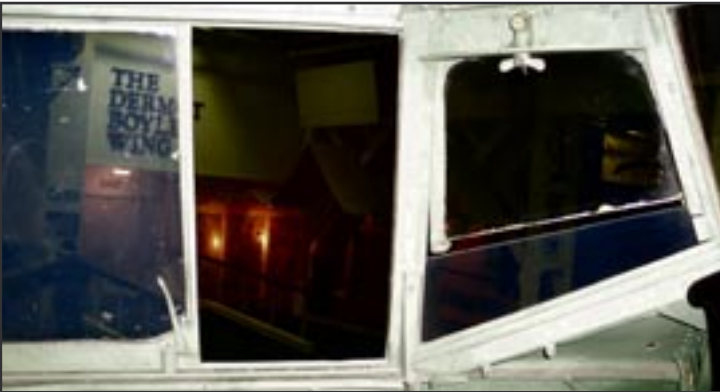
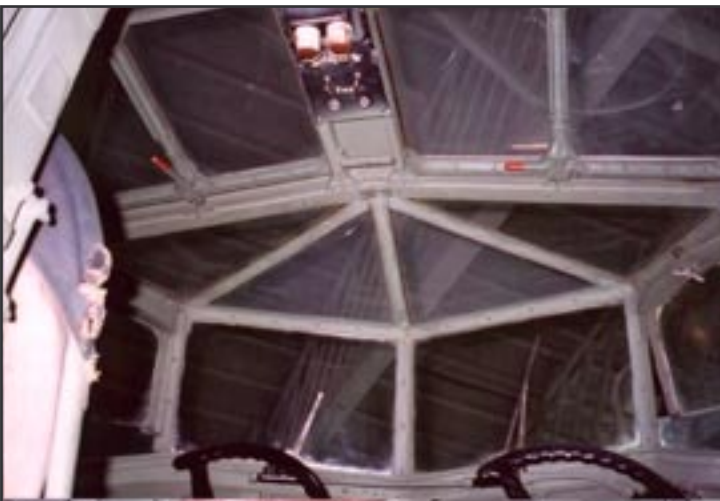
STRANRAER- Cockpit

Unfortunately, the interior of 920 is gutted, thanks to theft while in open store in Canada, so there is no instrument panel and almost no internal fittings left. The cockpit glazing of Stranraer 920 clearly shows a family resemblance to the Walrus, although much larger. The view from the pilot's seat (centre) shows how substantial the structure is.

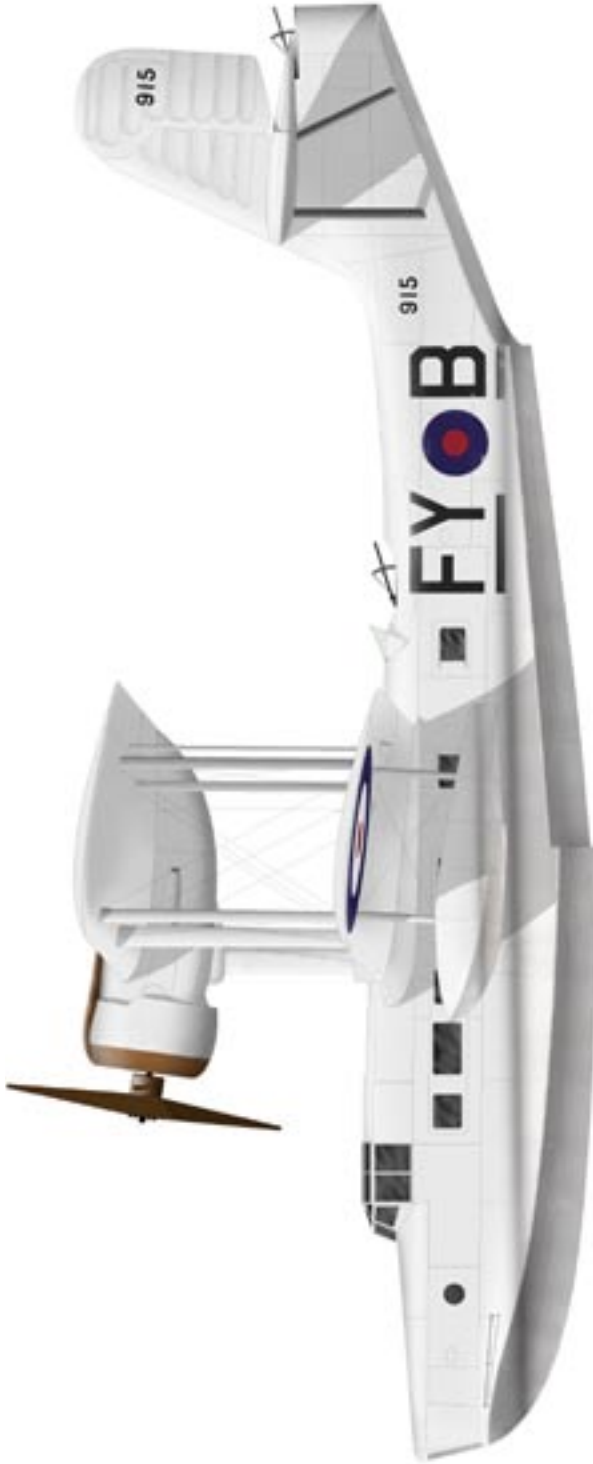
Stranraer 915 FY-B, 4 (BR) Sqn RCAF, RCAF Station Ucluelet, Vancouver Island, British Columbia. Seen in overall aluminium finish with type B roundel on the hull. Note the wooden four bladed propeller comprising two two-bladed units.

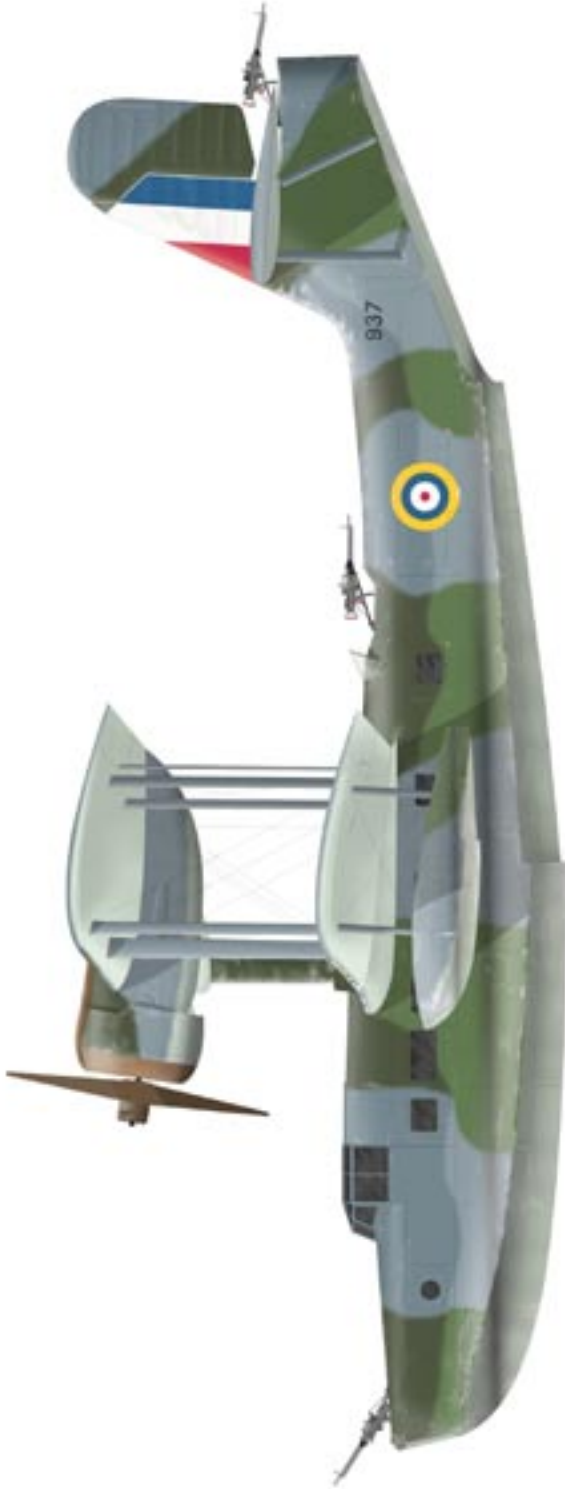
Stranraer 937. 9 (BR) Sqn RCAF, RCAF Station Bella Bella, British Columbia, 1942-43. Seen in four colour counter shading. Lower surfaces are in sky. No codes carried at this time. This aircraft was seen in photographs with all guns mounted - unusual on most Stranraer operations.

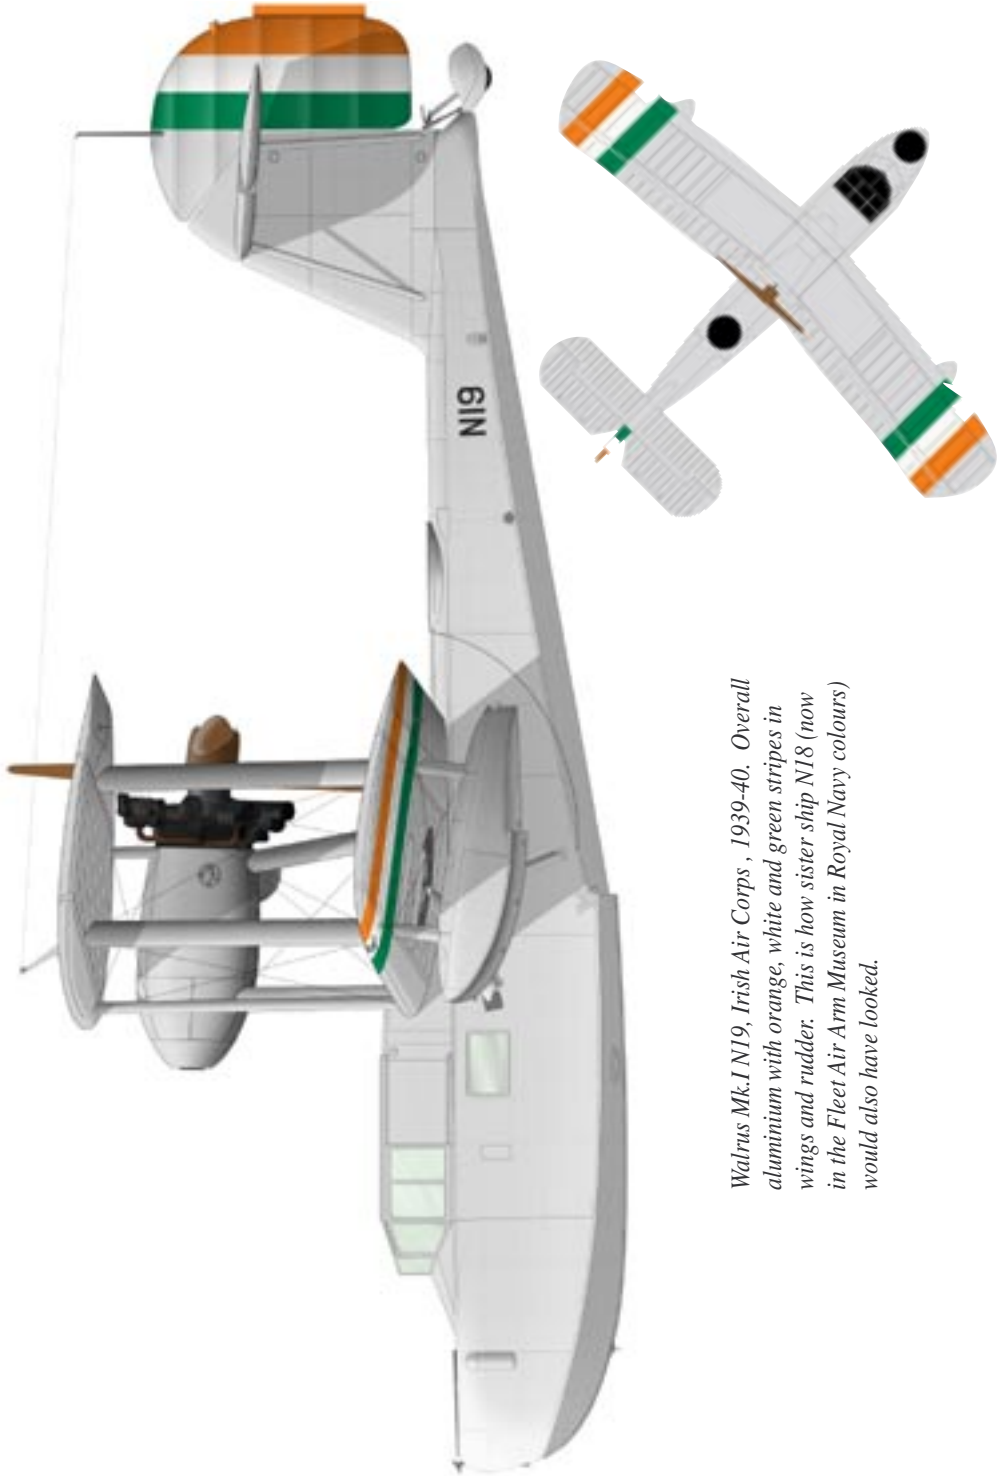
Walrus Mk I N19, Irish Air Corps , 1939-40. Overall aluminium with orange, white and green stripes in wings and rudder. This is how sister ship N18 (now in the Fleet Air Arm Museum in Royal Navy colours) would also have looked.

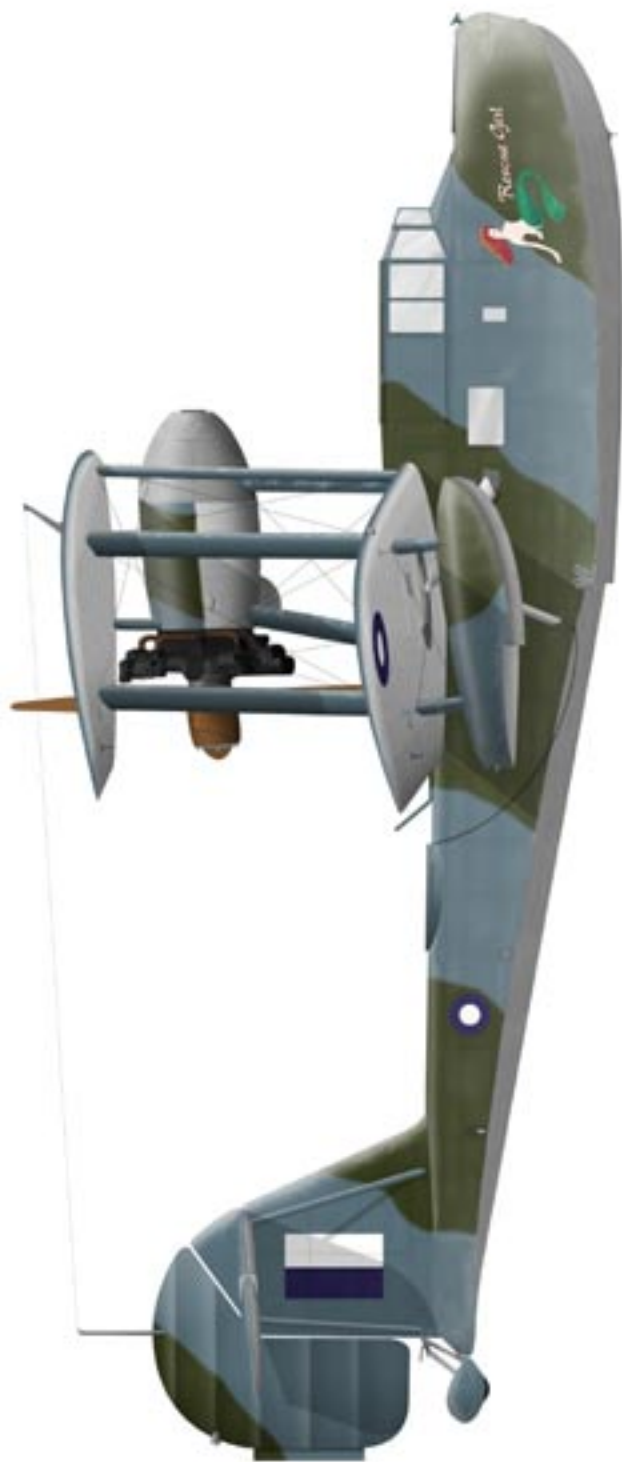
RAAF ASR Walrus Mk.I „Rescue Girl” (unknown serial) serving with 71 Wing in the Admiralty Islands, Sept 1944. Colours of the mermaid are unconfirmed. Note the primer painted front half of the engine nacelle.

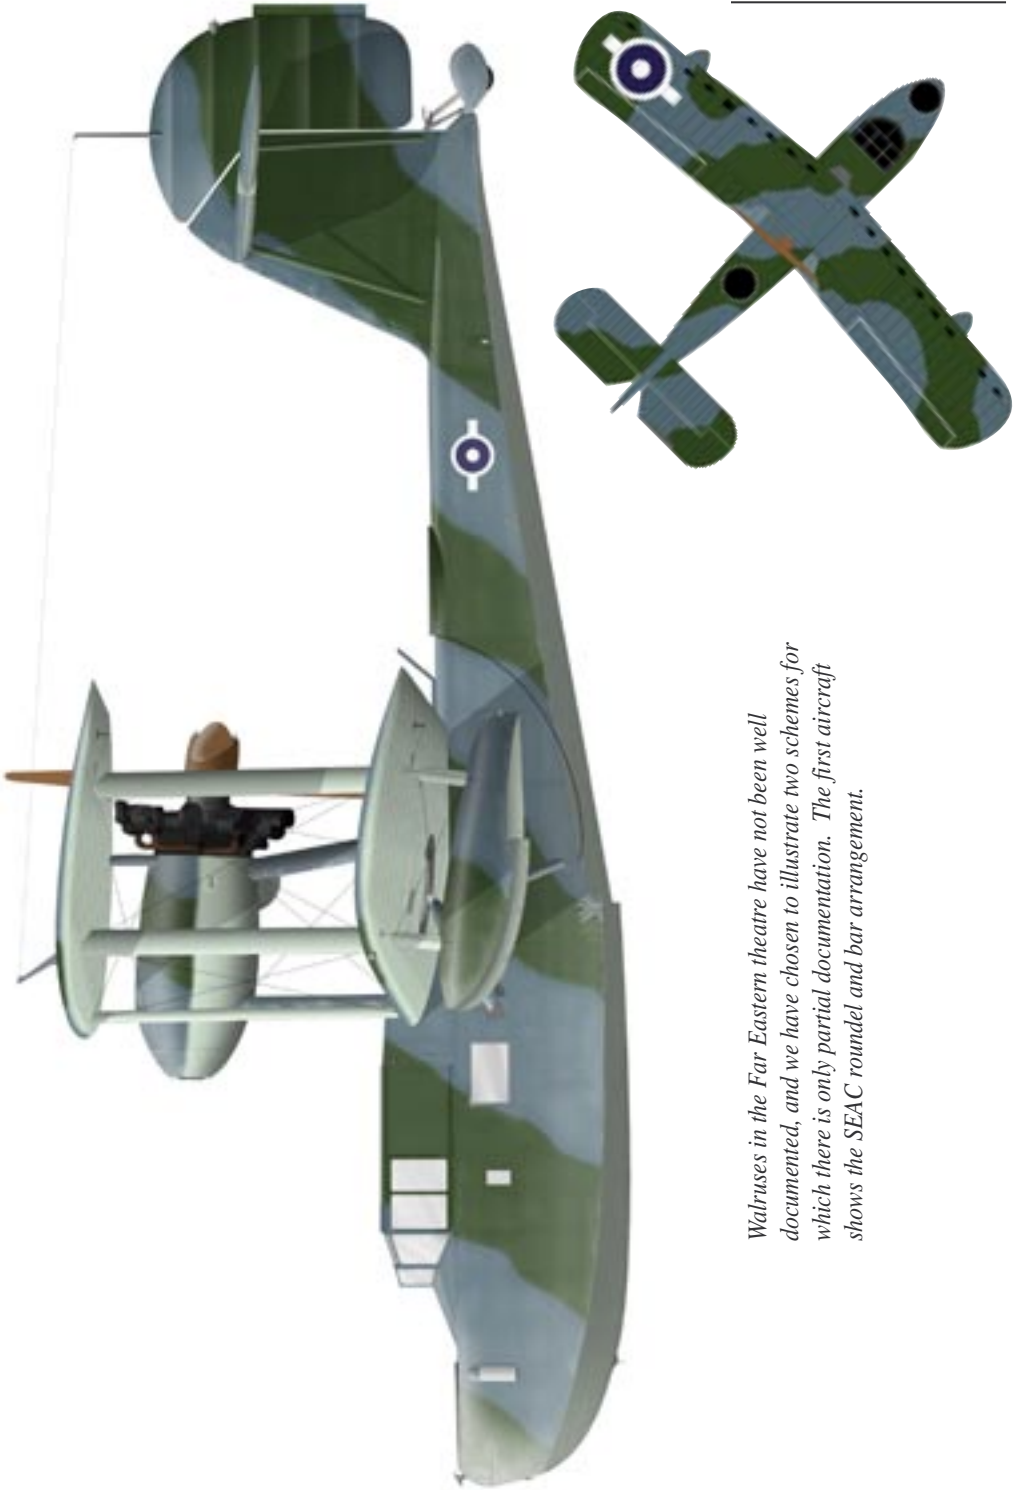
Walruses in the Far Eastern theatre have not been well documented, and we have chosen to illustrate two schemes for which there is only partial documentation. The first aircraft shows the SEAC roundel and bar arrangement.
